IMPORTANT

DHD 100-449 Repair Harness for 2001-2005 Allison 1 Plug NSBU

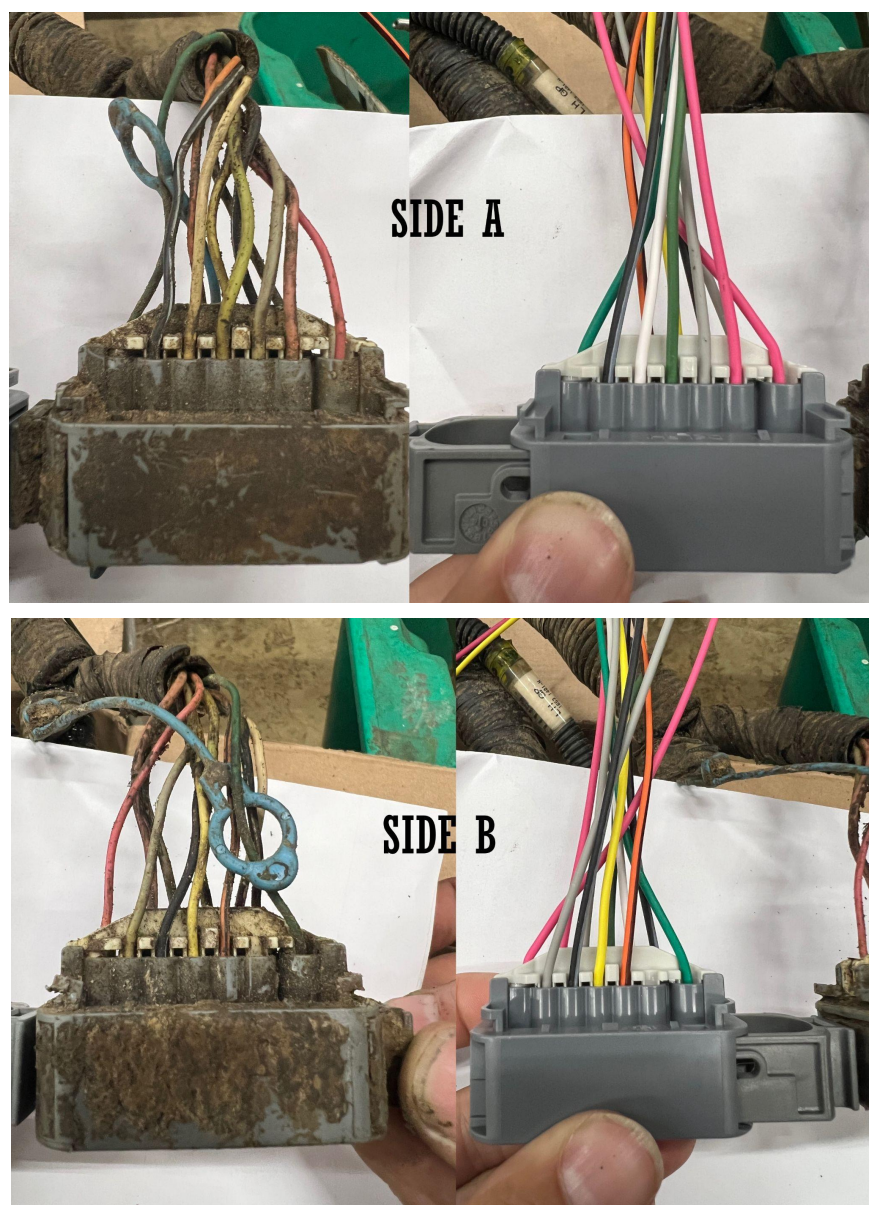
Installation of this repair harness requires attention to detail. It's always best practice to install this repair harness 1 wire at a time. Wire coatings can discolor overtime so always match your wires based on pin location, not wire color. The pictures below are an example of correct pin layout and color match vs a used harness.
